## MITIGATION PLAN

### **Al Helenberg Memorial Boat Launch Maintenance Dredging** *Castle Rock, Washington*

Prepared for  
**City of Castle Rock**  
P. O. Box 370  
Castle Rock, Washington 98611  
(360) 274-7478

*Prepared by*  
**Ecological Land Services**  
1157 3rd Avenue, Suite 220A • Longview, WA 98632  
(360) 578-1371 • Project Number 102.89

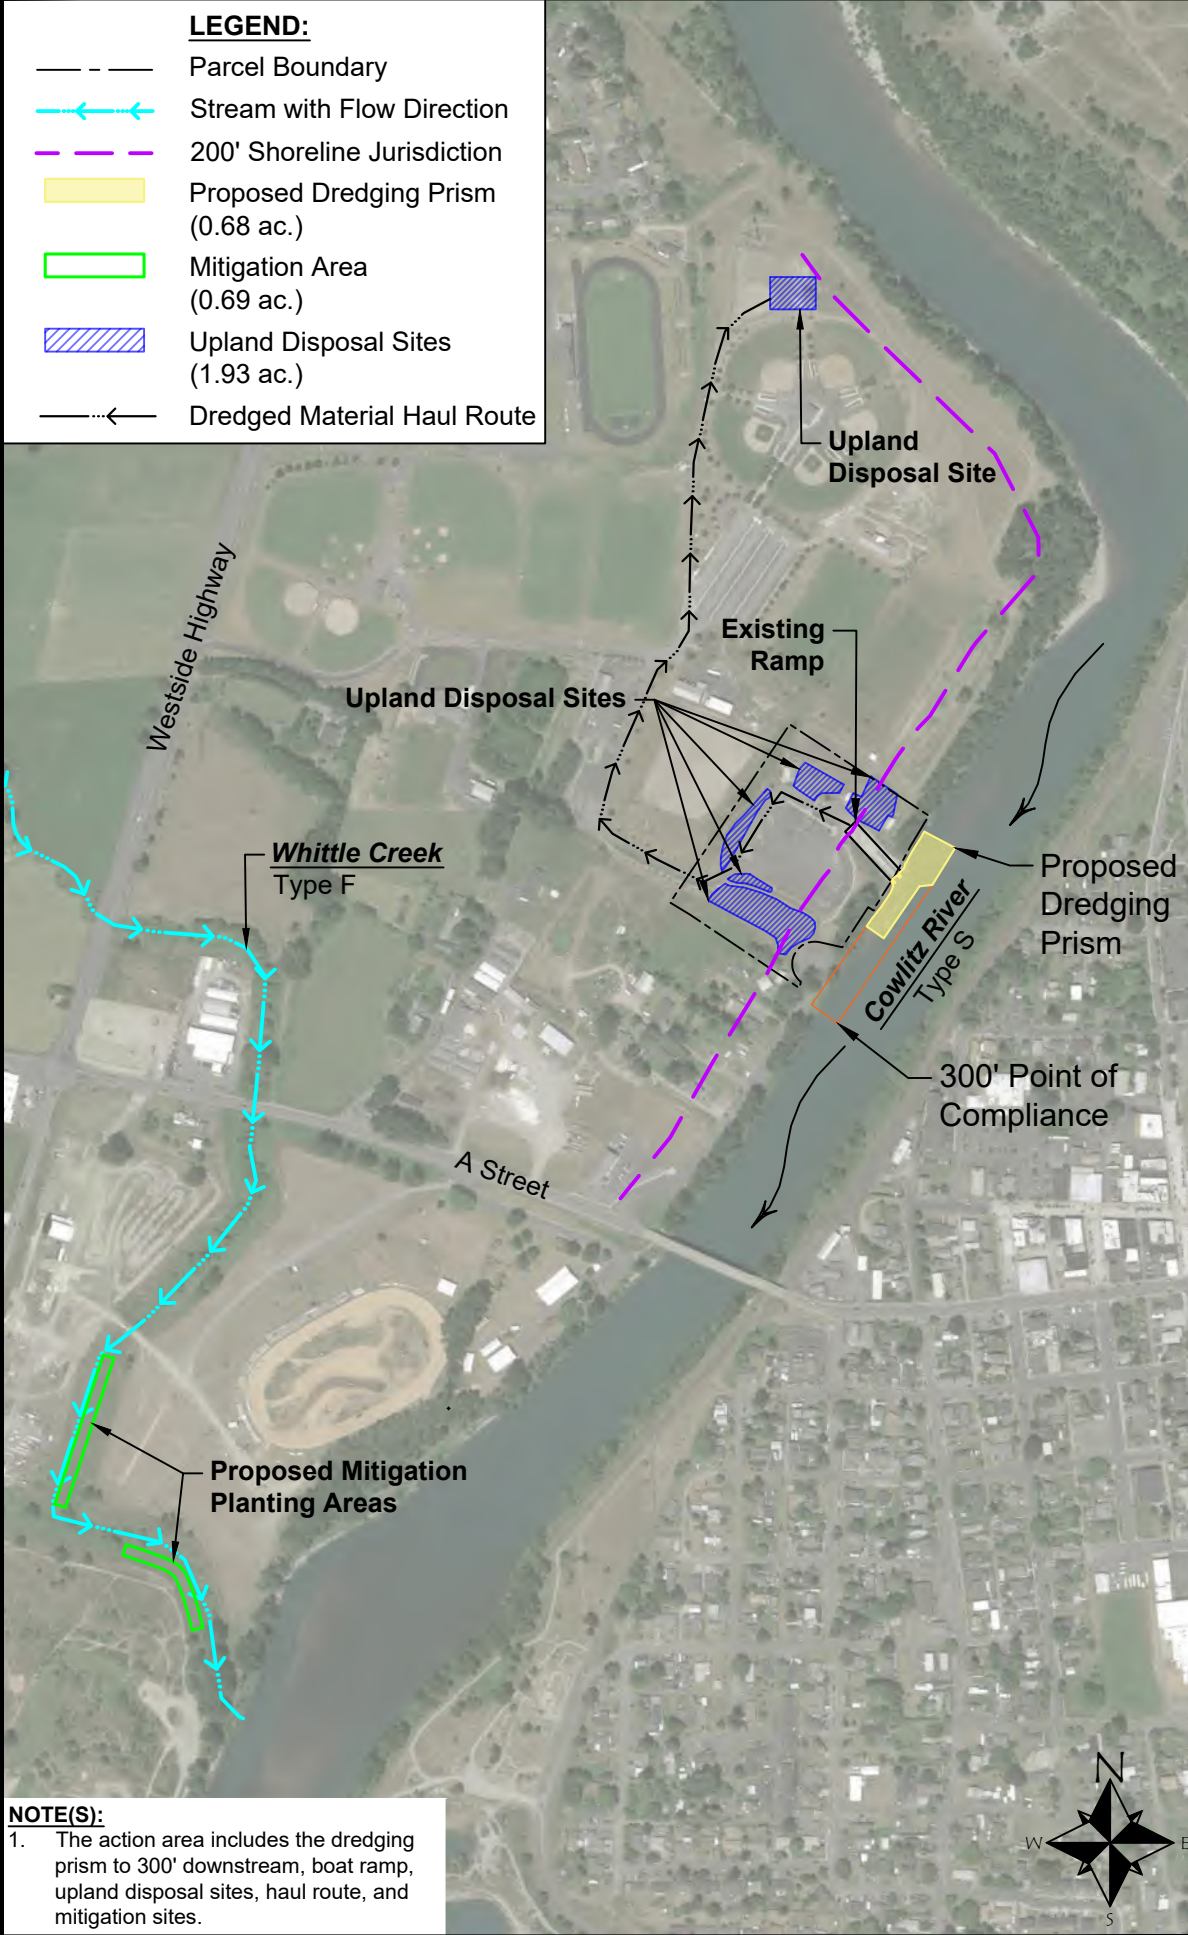
| <b>SHEET</b> 5 <b>OF</b> 7 | <b>SITE LOCATION ADDRESS:</b><br>RM 17.6 - Access Rd 5040 Westside Hwy | |

- Parcel Boundary
- Stream with Flow Direction
- 200' Shoreline Jurisdiction
- Proposed Dredging Prism (0.68 ac.)
- Mitigation Area (0.69 ac.)
- Upland Disposal Sites (1.93 ac.)
- Dredged Material Haul Route

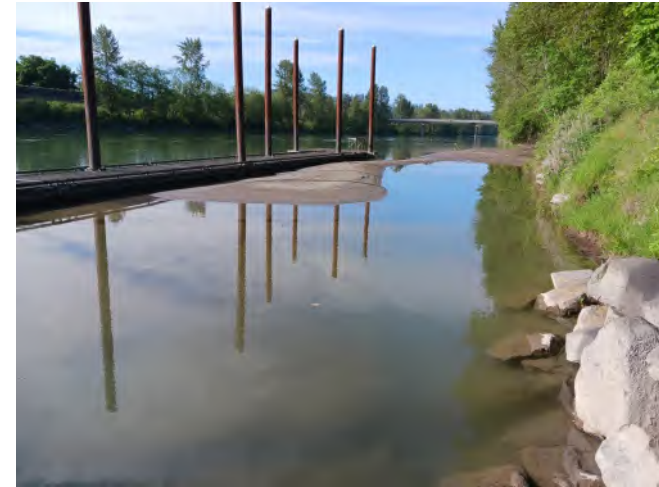
**Photo 2.** Taken June 2025. Looking downstream at dock shown in Photo 1. Both photos were taken at similar river levels. Photo 2 shows significant sediment accumulation.

The estimated volume of material to be removed initially is approximately 500 cubic yards. During a site visit on June 2, 2025, it was noted that a significant sediment build-up has occurred between

the dock and the shoreline, as shown on the photoplate. It compares a photograph taken in June 2020 with photographs taken on June 2, 2025.

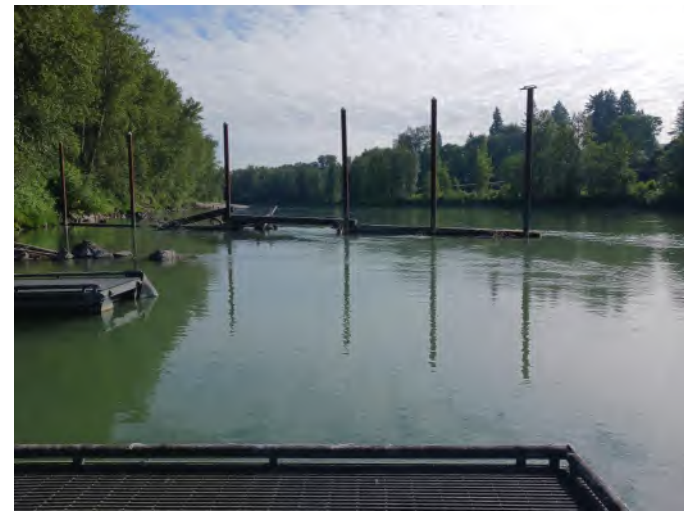
**Photo 4.** Looking upstream at log boom. Photo taken June 2025.
